# INSPECTION UPDATE

WINTER 2024  
VOLUME #25, ISSUE 4

### Intermittent No-start Issue

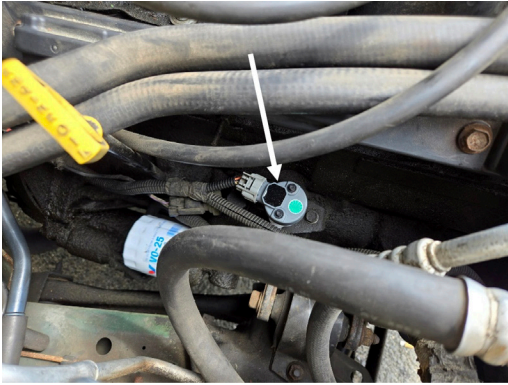
The article is about a vehicle that had previous work done by the customer and other shops where the coil pack and crank sensor were replaced (about a year ago). The customer replaced the cam sensor and crank sensor himself, but continued to have stalling and no start issues.

The first time I saw the Jeep Cherokee Sport 4.0L, it was towed in as a crank no start. I found a stored P0340 no cam signal. The engine had a new cam reluctor and sensor installed, and I verified the reluctor was turning when the engine was cranked. I also verified the cam sensor had a 5v reference, a ground, and there was 5v on the signal wire with the sensor unplugged. I scoped the signal wire when cranking and there was just a constant 5v, no square waves, so I replaced the cam sensor. The engine started right up. I drove the Jeep around a bit, and it ran fine and restarted normally. I declared the Jeep fixed, and the customer picked up the vehicle.

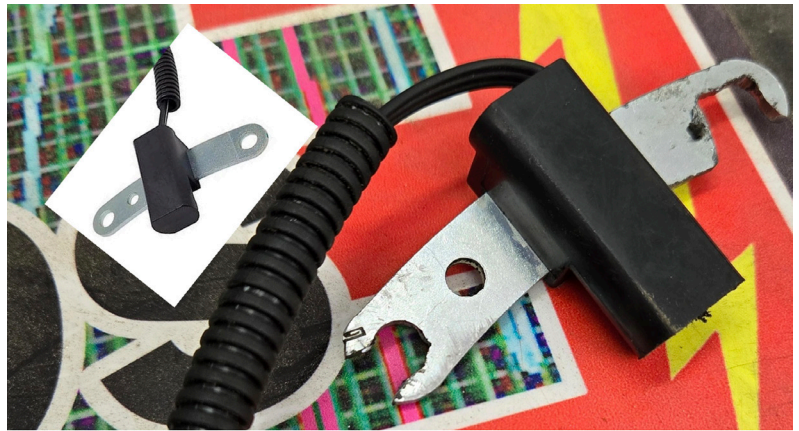
The crank sensor bracket was cut and hacked up. After further discussion with the customer, he said it was very difficult to hold the sensor and start the bolts at the same time, hence he modified the bracket to allow him to start the bolts first and then slide the sensor onto the bolts. (Umm, yeah that's not how it works)

Once again, I had discovered an obvious problem and assumed that a new crank sensor would fix this permanently. I did my due diligence and inspected the tone ring. I used a mirror to look through the bell housing hole while someone turned the engine over for me. Since the tone ring looked perfectly fine, I ordered and installed a new crank sensor.

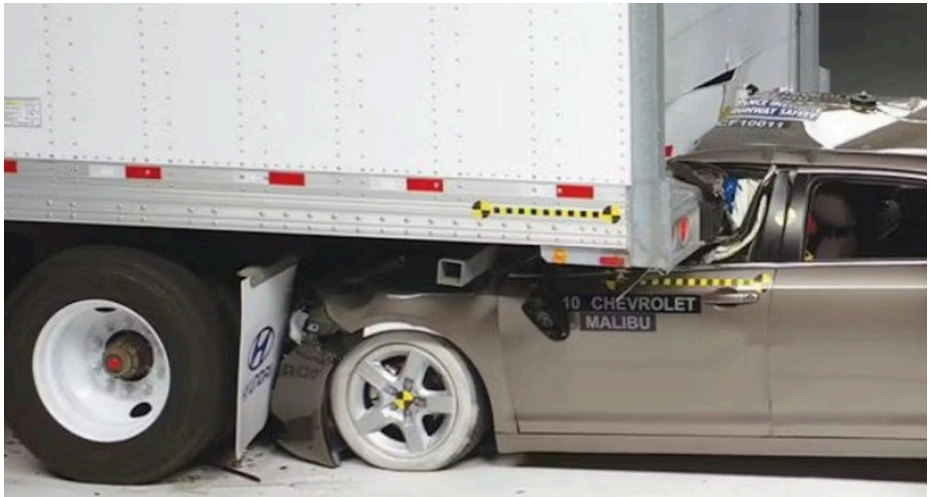
- **Condition:** Inspect the guard's overall condition for damage, corrosion, or any other structural issues that may affect its effectiveness.
- **Mounting and Attachment:** Ensure that the rear impact guard is securely attached to the vehicle and properly mounted according to industry standards.
- **Clearance:** The space or clearance between the ground and the bottom edge of the rear impact guard. This clearance is crucial to ensure that smaller vehicles do not slide under the rear of the larger vehicle in the event of a collision.
- **Welds and Fasteners:** Examine the welds and fasteners for signs of wear, damage, or rust that could compromise the guard's structural integrity.

The rear impact guard requirements were established to enhance safety by reducing the risk of underride crashes, where a vehicle can slide under the rear of a commercial vehicle during a collision.

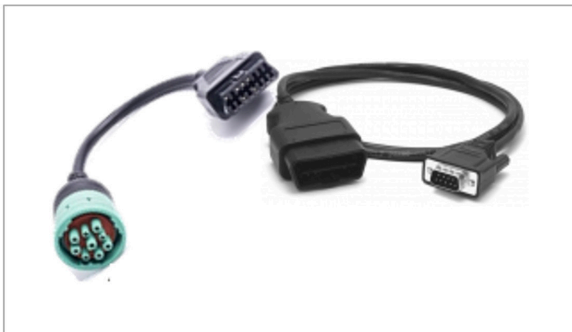
Tachometer and Temperature (tach/temp) data is also being gathered during opacity tests on all 2007 and newer vehicles. This is a reminder to inspectors that you must “snap” the throttle as directed during the opacity test. Trying to lightly feather the throttle will result in extra snaps and a failed test.

There has been a relatively high communications failure rate mostly due to inspectors bypassing the tach/temp data gathering and also the OBDII data connection. To properly gather this data, the OBDII connector from the workstation should be plugged directly into the vehicle's factory OBDII connector.

Plugging into an aftermarket OBDII connector due to a data logger or other device being plugged into the factory connector can lead to no communication. When using the 6 or 9 pin Deutsch connector adapters, it is essential to use the locking ring when making the connection to the vehicle. Failure to do this can result in no communication. The best way to connect is to note the position of the
